## Nature oriented stream bed stabilization: Dala Leukerbad (VS)

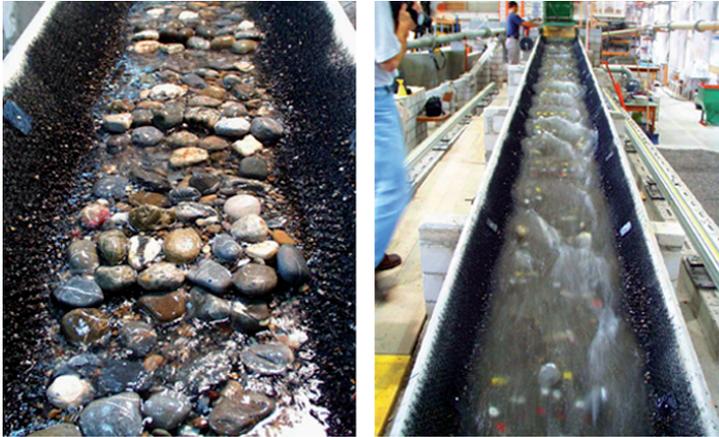
Flow condition at low and high stage in the laboratory flume. The discharge at high stage was the design discharge (42 m<sup>3</sup>/s).

step-pool morphology with an averaged slope of 8%. The existent bed material ( $d_{90} = 0.4$  m) was additionally stabilized with several heavy blocks (block diameter = 1-1.4 m and block placement density = 0.35 blocks/m<sup>2</sup>) in different arrangements. The so prepared stream bed was then impinged gradually on to the design discharge of 42 m<sup>3</sup>/s.

Five runs with different arrangement of the blocks were carried out. A strong restructuring of the blocks and the subjacent bed material was observed between discharges of 36 and 42 m<sup>3</sup>/s, depending on the arrangement. This global restructuring of the stream bed led to a rougher and more stable bed structure, which corresponds to the aspired natural mountain stream morphology. The block placement density of this new structure was more than 0.4 blocks/m<sup>2</sup>. The restructuring, however, was accompanied by a considerable mass loss in the upper flume section. For safety reasons this mass loss had to be avoided because in nature the accompanying depth erosion could endanger the stability of the embankments. Additionally blocks washed away by floods could lead to clogging of bridges downstream and so trigger inundations.

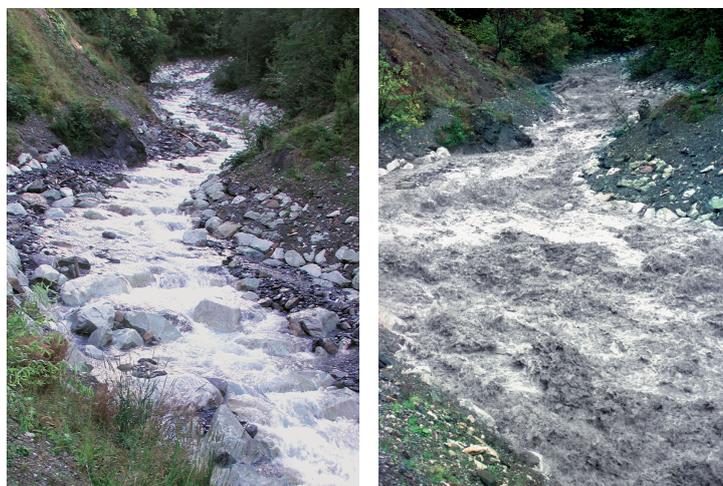
Flow condition at low and high stage in nature. The photo at high stage was taken during the flood event in October 2000 with a discharge between 25 and 30 m<sup>3</sup>/s.

Therefore, in nature the resulted step and pool morphology had to be approximated already during the construction. Thus, most blocks were arranged in steps oriented transverse to flow direction with a distance of 7-9 m between each other. Additionally, a block placement density of about 0.4 blocks/m<sup>2</sup> was aspired between the steps. This new bed stabilization withstood the flood event in October 2000 without any problems.
